**Buffer Zone Contamination Review
(Additional Assessment)**

**Prepared by the
Colorado Department of Public Health and
Environment**

April 2003

An Assessment of Site Disturbances at RFETS, April, 2003

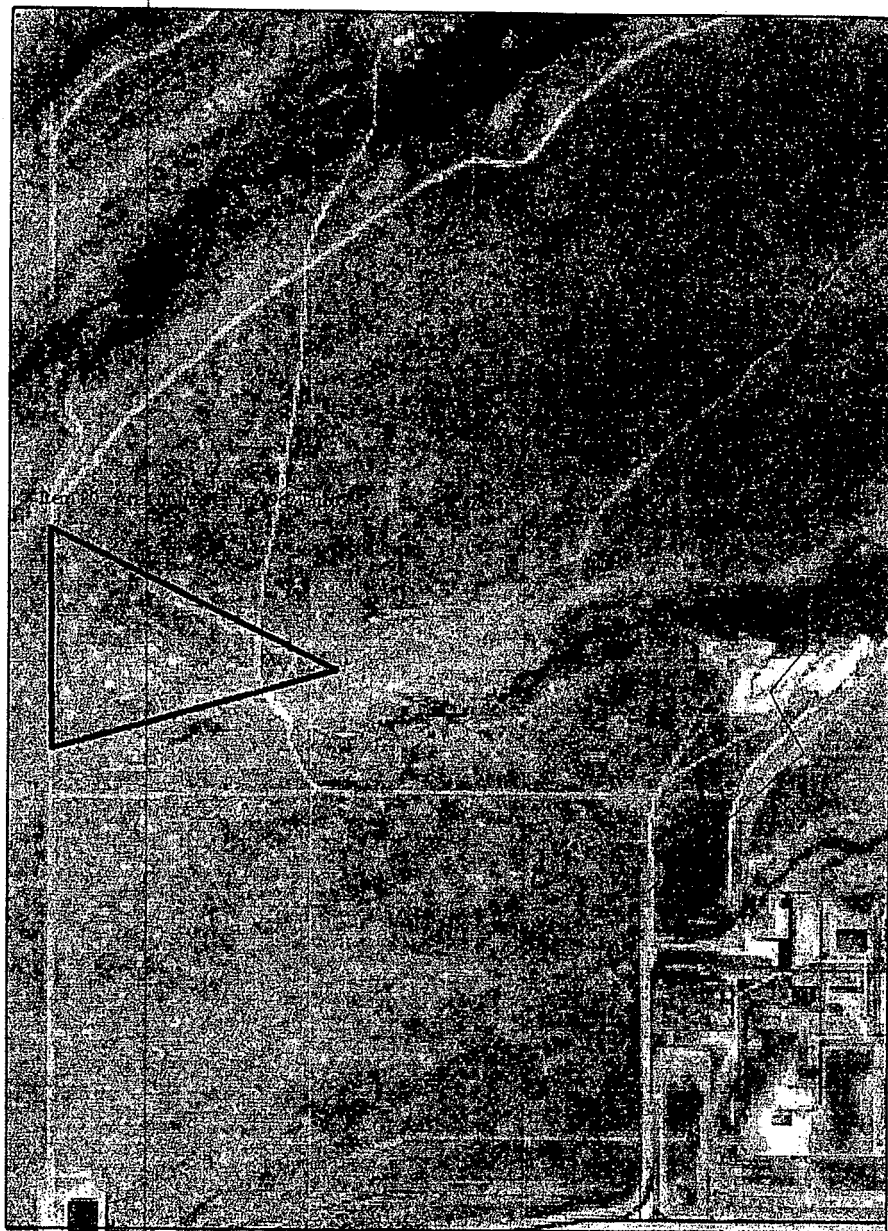
Item 20: 1962 Aerial Photo

Item 20, the general conclusion is these areas are indeed either active prairie dog mounds or remnants of their occupation. As these remnants are noted prior to the IA and the explanation in DOE 2001, is likely except for two areas.

Two areas, one noted in the 1962 photo and another noted in the 1969 photo show paths created by vehicles. (See photos attached). Furthermore, the size of the circles has changed particularly for the area covered in the 1969 photos. More importantly the 1969 photo examined stereoscopically at Colorado Aerial Photo show shadows made from vertical cylindrical manmade objects. These objects would be considerably larger than drums. Therefore, these areas are in need of further investigation to determine the nature of the disturbances. The disturbances are still prominent in 1970, but not by 1978. This information was presented to the stewardship group at DOE for their examination.

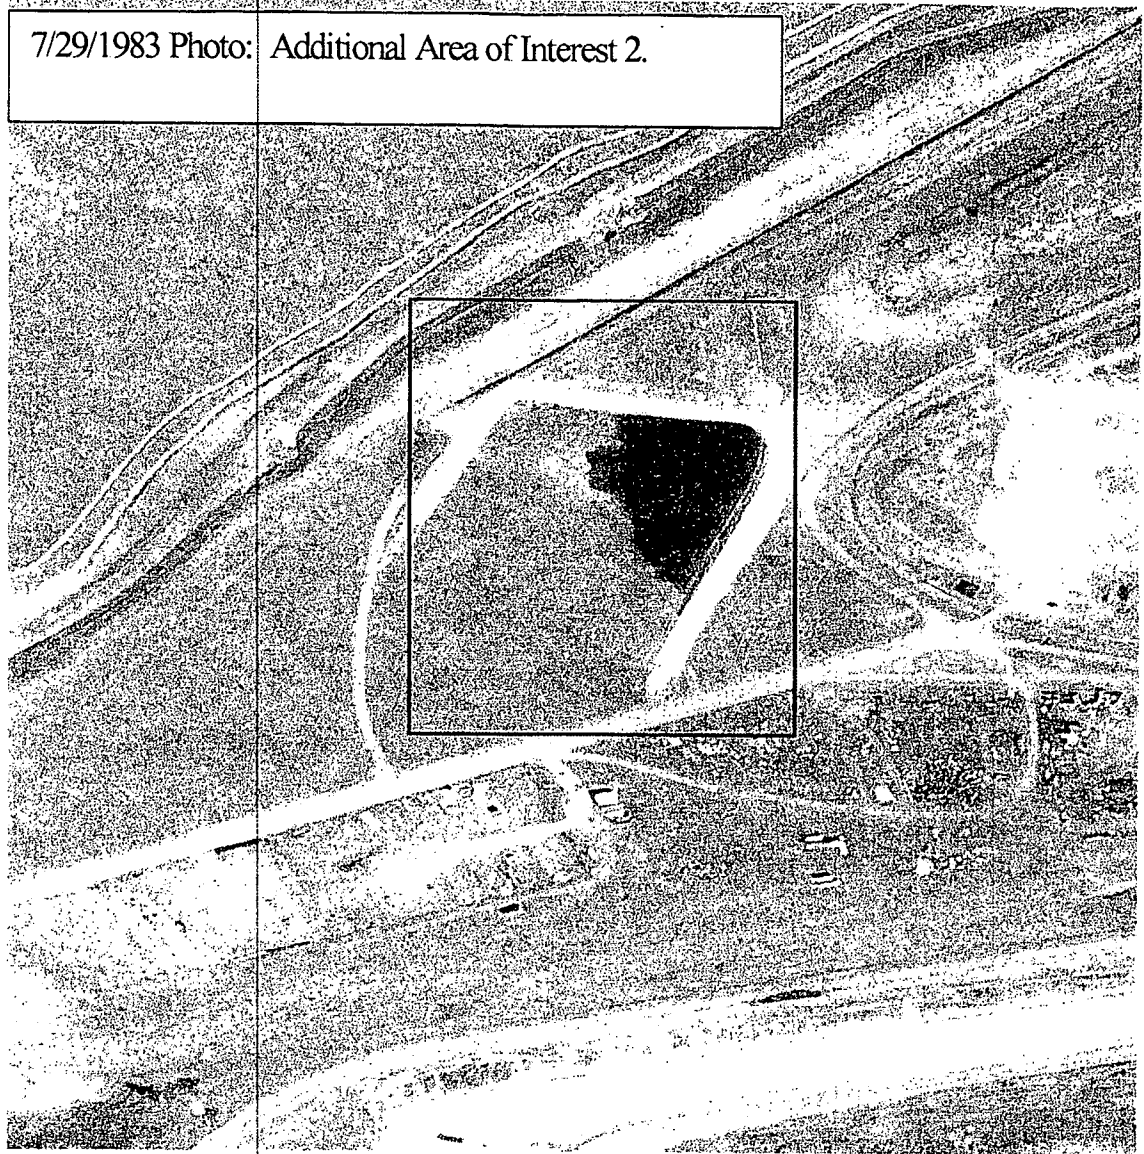
7/29/1983 Photo: Additional Area of Interest 2.

2. The 7/29/1983 aerial photo shows a constructed water holding area west of the present landfill. The purpose for and contents of this activity need to be documented and possibly investigated. (See photo attached)

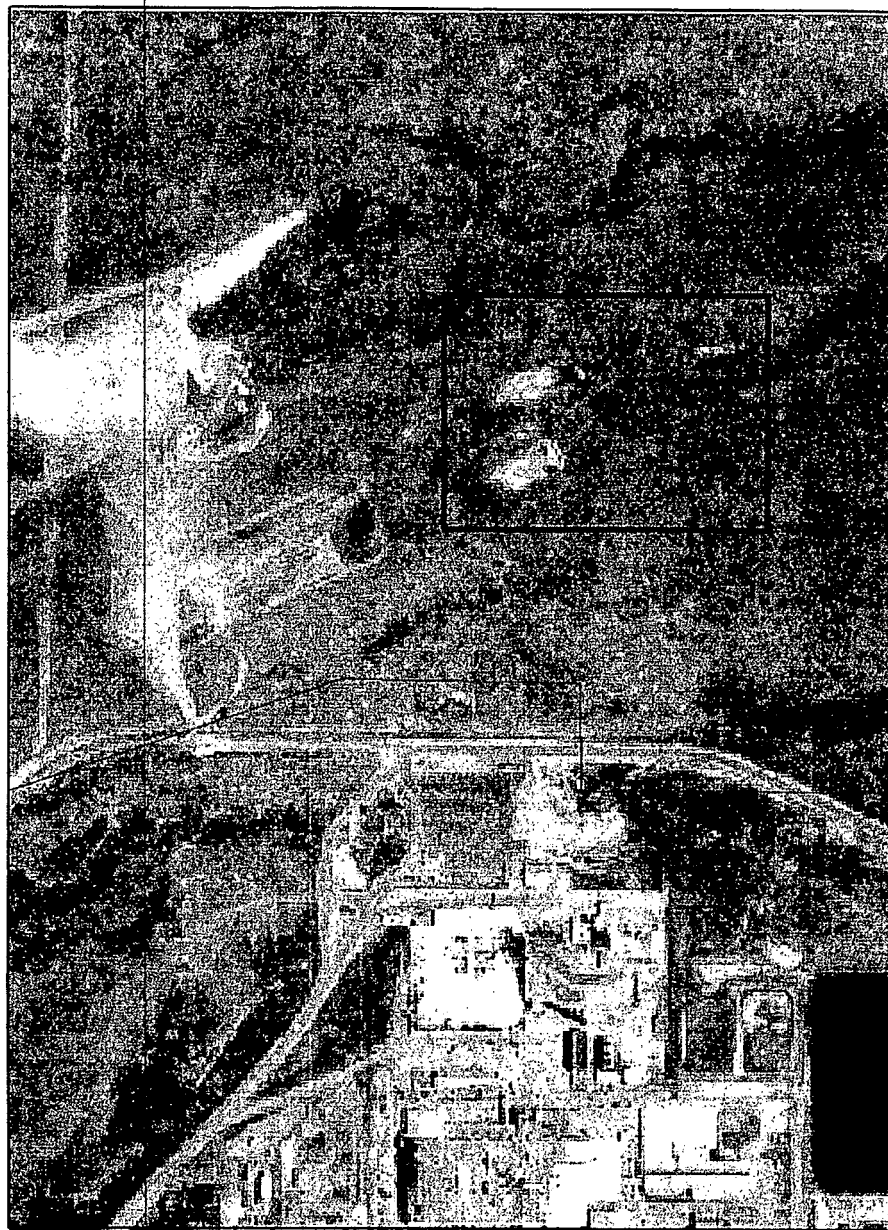
7/1/1969 Photo: Additional Area of Interest 3.

3. The 7/1/1969 photo shows 2 disturbed areas due east of the present landfill and slightly south. What these disturbances were caused by needs to be documented and possibly investigated. (See photo attached)

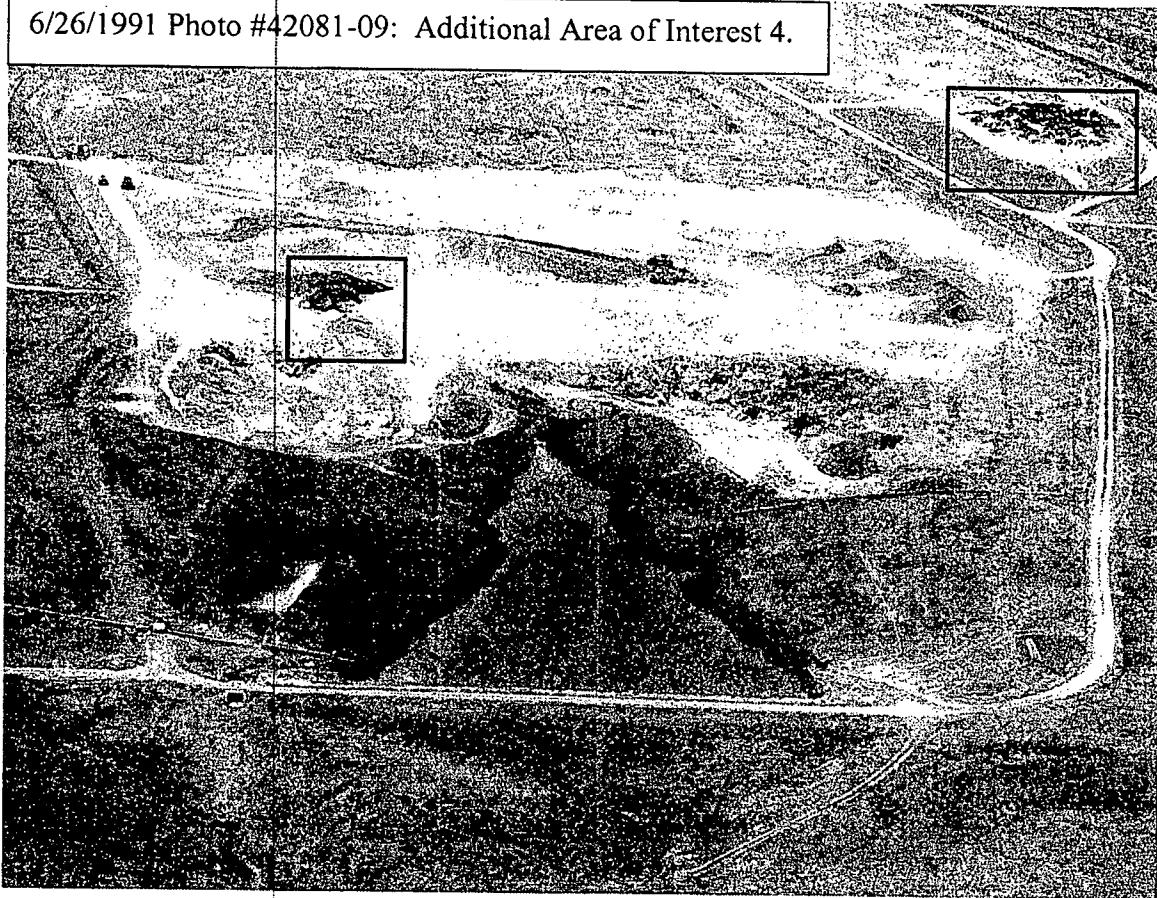
6/26/1991 Photo #42081-09: Additional Area of Interest 4.

4. The 6/26/1991 photo 42081-09 shows two dark mounds of material one north and one west of the present landfill. The material is possibly asphalt. What this material is, where it came from and what its ultimate disposition was needs to be investigated and documented.
